Vehicle History Report

Chassis number ¹: GVF-003924

Make: SUBARU

Model: IMPREZA

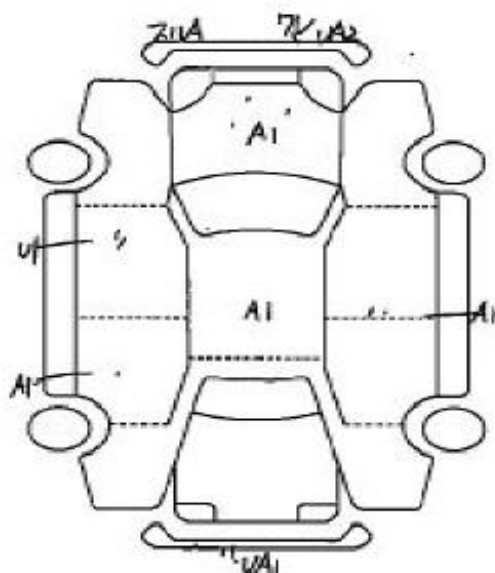
検査員 FW キズ・~~凹~~石・ヒビ割・リペア跡・X要
記入欄 内装 キズ・~~傷~~し・コゲ・穴・スレ・ヘタリ・破れ
ドアミラー ~~③~~ズ・ワレ ホイール・キャップ ~~③~~ズ・ワレ

各キズ

ドアブパネ
