Vehicle History Report

Chassis number ¹ :	ZN6-006164	Title information ² :	, 60	Deregistered to Export	0
Manufacture date:	2012		U -		
Make:	ΤΟΥΟΤΑ	Accident / Repair:	ļ₽,	No problem	\sim
Model:	86	Odometer rollback:		No problem	0
Body:	DBA-ZN6	Manufacturer	~		-
Grade:	G	recall:	۲	No problem	\checkmark
Engine:	FA20	Safety grade ³ :	0	****	\checkmark
Drive:	2WD	Contamination			_
Transmission:	AT	risk:	Å	Problem found	•

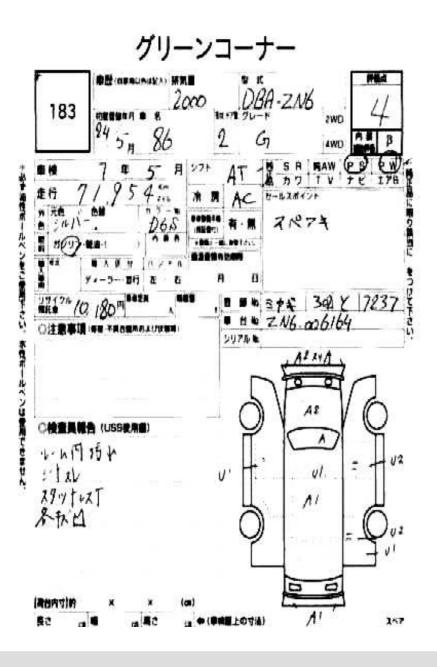
PHOTOS AND AUCTION SHEETS

Date:	2024-11-13	Lot #:	183
Auction name:	USS Tohoku	Region:	Miyagi
Make:	ΤΟΥΟΤΑ	Model:	86
Reg. year:	2012	Mileage (km):	71954
Displacement (cc):	2000	Transmission:	AT
Color:	SILVER	Model code:	ZN6
Result:	available	Auction grade:	4
Problem type:	No problem	Problem scale:	None
Contaminated:	Yes	Airbag:	ОК
