Vehicle History Report

Chassis number ¹: Z34-300323

Make: NISSAN

Model: FAIRLADY Z

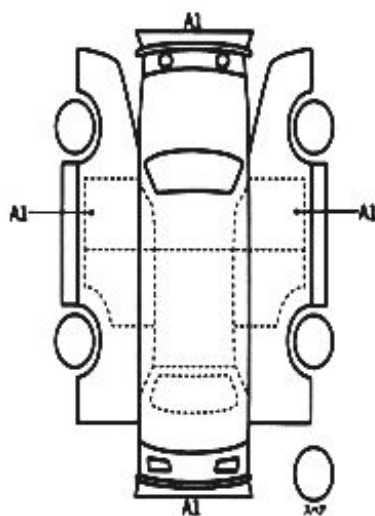
ダッシュ板ワレ、ベタつき
シートヒビ、ハゲ
ハンドルスレ
