Vehicle History Report

Chassis number [1]:	ZN6-046649
Manufacture date:	2014
Make:	TOYOTA
Model:	86
Body:	DBA-ZN6
Grade:	GT
Engine:	FA20
Drive:	2WD
Transmission:	AT

Date: 2025-07-04, Auction: USS Osaka, Lot #: 66

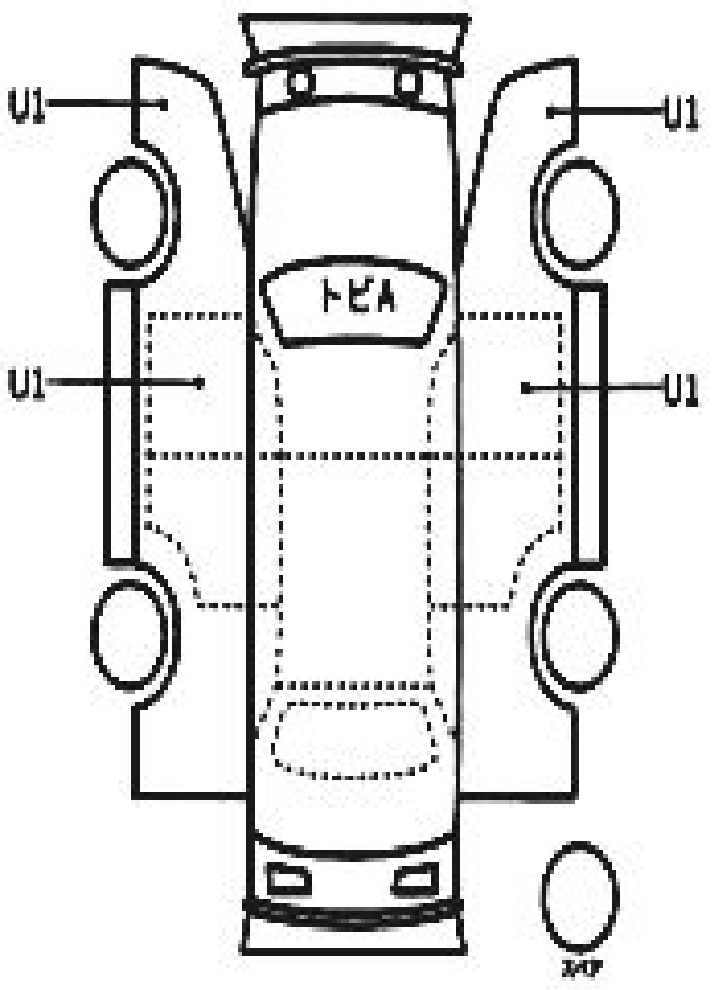
○注意事項
☆TRDエアロスタビライジングカバー
☆TRDリアトランクスポイラー
☆TRDリアサイドスポイラー
☆社外足回り
☆メーター－パネル内一部加工？

○検査員報告
外品ハンドルスレ
外品ヘッドライト
外エキマニ、触媒、純正1個欠
シートフチシワ
ホイールキズ
